<b>INSPECTION REPORT</b>			Report No: 01	Date: 3 Nov. 2013	Page 1 of 11
<b>CUSTOMER DATA</b>			<b>MI DATA</b>		
Client	Hebei Abter Steel Pipe Co.,Ltd		MI Project No.	29020-1	
Supplier Job No:			Project Name	Yallourn Project	
Location:	Taida Building, Yingbi North Road, Yunhe District, Cangzhou City, Hebei Province, China		Requisition No:	N/A	
	Hoffman Fang		Date of Order:	N/A	
Inspection Performed:	<input checked="" type="checkbox"/> With Customer Supplier <input checked="" type="checkbox"/> With Sub-Supplier		MI Contract Coordinator:	Cathy Brooks	
P.O. No:	Change No:	Requisition No:	Date(s) of Visit(s):	Oct, 16 2013/Oct 29,2013/Nov 2,2013	
13YFS92-A Rev.1		N/A	Date of Previous Visit:	N/A	
<b>INSPECTION DISPOSITION:</b> <input checked="" type="checkbox"/> Accept <input type="checkbox"/> Nonconformance(s) Identified <input type="checkbox"/> Placed on Hold <input type="checkbox"/> Other (Explain)

**Date: Oct. 16,2013-External FBE**

**Date: Oct.29,2013-Finished Products**

**Date: 2 Nov.,2013-Container Loading**

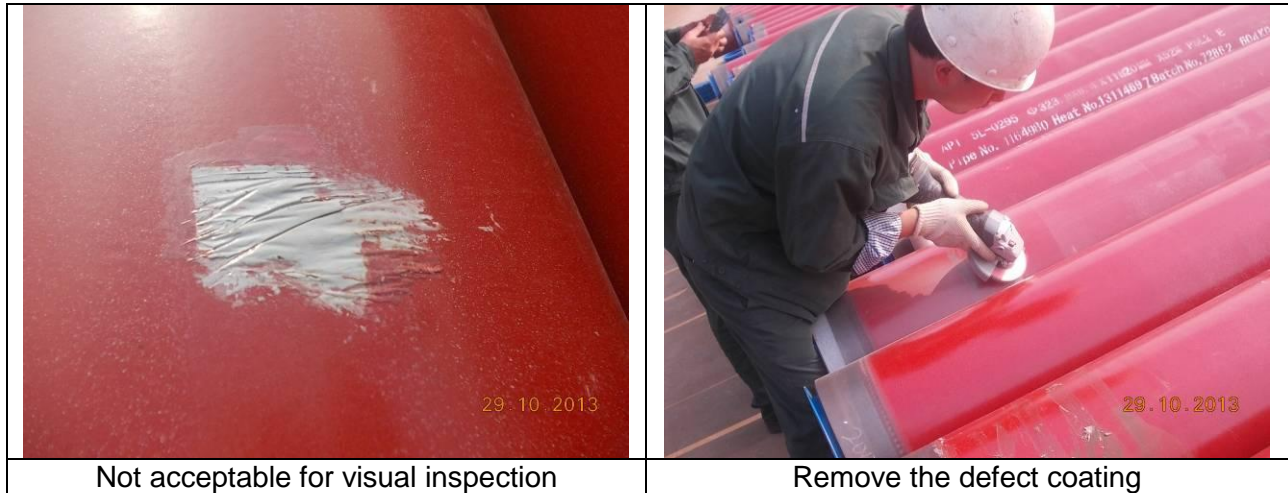
- 6.4.1 Visual, dimensional, marking verify before coating
- 6.4.2 MI inspector performed the visual inspection for the external coating at random, found the surface of 5 repaired area were not smooth, and then the worker removed them and repair it.
- 6.4.3 MI inspector performed the visual inspection for the internal coating at random, the pits were found on the end of each pipe, which were caused by the wet film thickness test, MI inspector could not measure the thickness of this parts whether meet the requirement, and the surface was not flat, then the factory replied that they were repairing them, and the repair work would be finish on 30<sup>th</sup>, Oct. 2013.

Not acceptable for visual inspection

Remove the defect coating

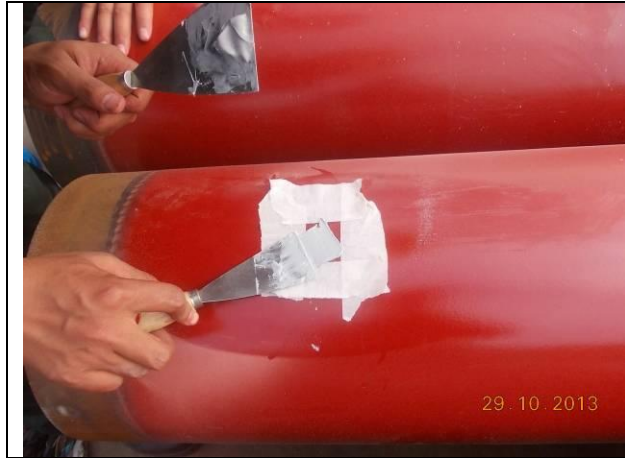
Re-coat

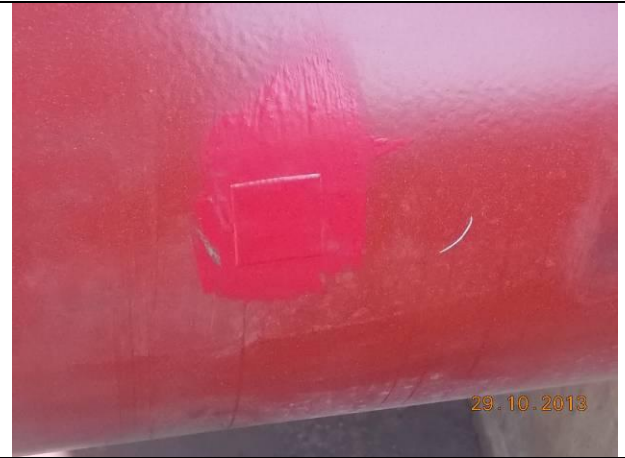
After repair

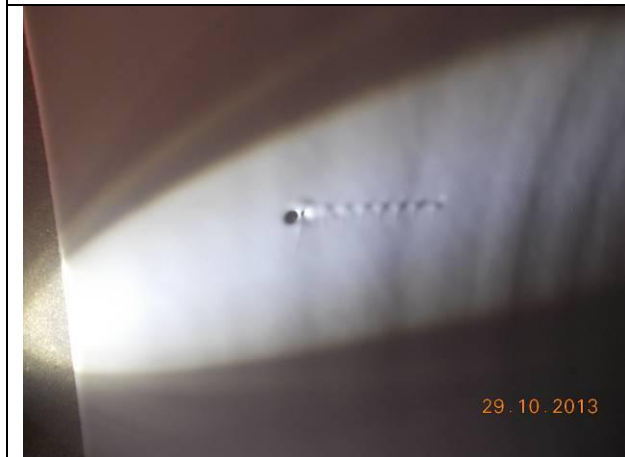
Pits were found

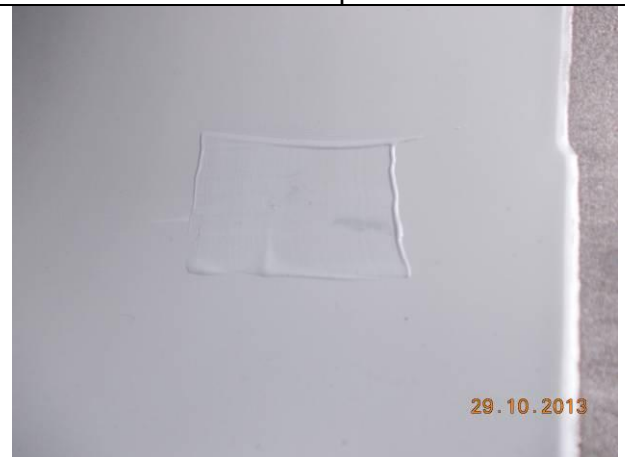
After repaired (need grind smooth)

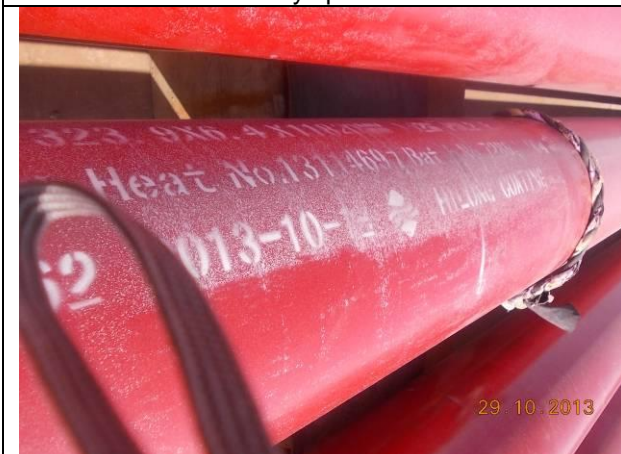
Internal coating were found on the external surface (Atomization)
