Inspection Order No. : IN-SH-PSI-09338
Page No. : 1 of 7
Date of issue: November 12, 2009

INSPECTION REPORT

- Description and Quantity of Commodity: OCTG SEAMLESS API 5-CT J 55 R2 EUE 3000M
3 1/2" x 9.3PPF
- Name & Address Of Client: Hebei Abter Steel Pipe Co., Ltd
- Name & Address Of Mill:
- Inspection Date & Place:
- P/I No.: BC09102006 DTD 2009.10.21
- L/C No.: N/A
- Nature Of Inspection:
 - Quantity check
 - Visual quality check (sample size: ANSI/ASQ Z1.4 - 2003-L-2)
 - Packing and Marking check
 - Dimension check(sample size: ANSI/ASQ Z1.4 - 2003-L-2)
 - Witness testing- chemical composition, mechanical properties, hardness testing, Hydro testing and etc. (sample size: according to the heat No.)
 - MTC review and endorsement
- Inspector: Xu Sheng

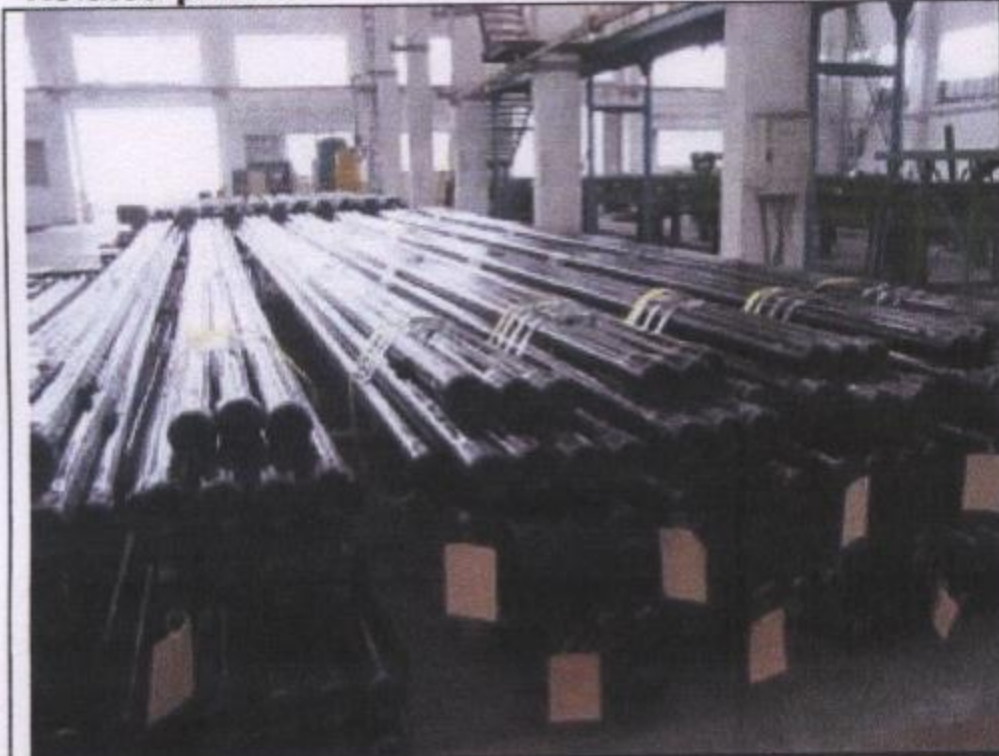
At inspection site, total 17 bundles were found.
Each bundle was trussed into 19 tubes, total 323 tubes were found.

At inspection site, total 19 bundles (323pcs) were found.

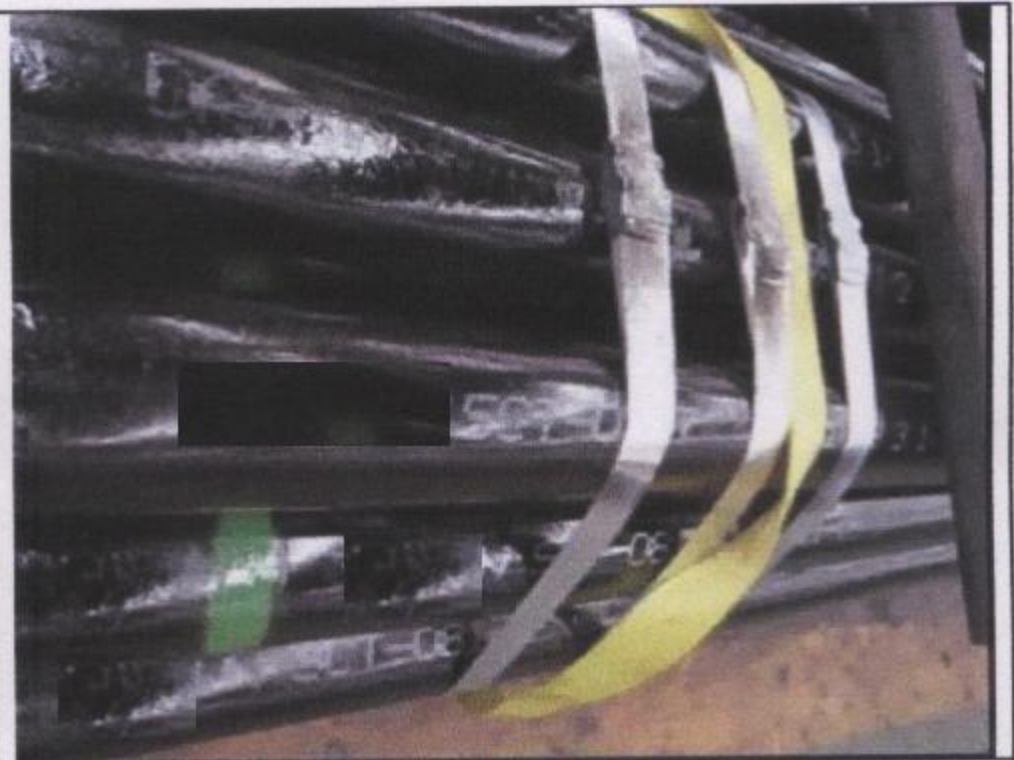
Each tube was printed related marking, one of markings as below:

11-09 3 1/2" 9.3 JZS P6400 EU D 31.33 FT 292.92 LB Y909-100 9AJEAN01 10790

Each tube was printed related marking.

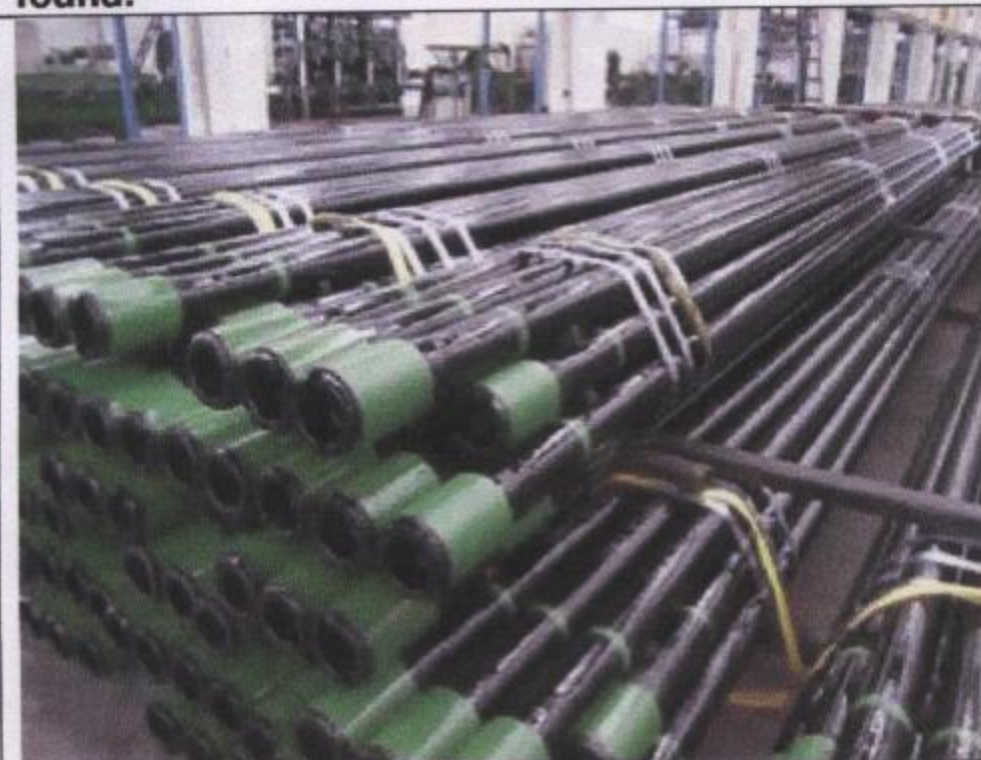
Female end had been put on protection caps.

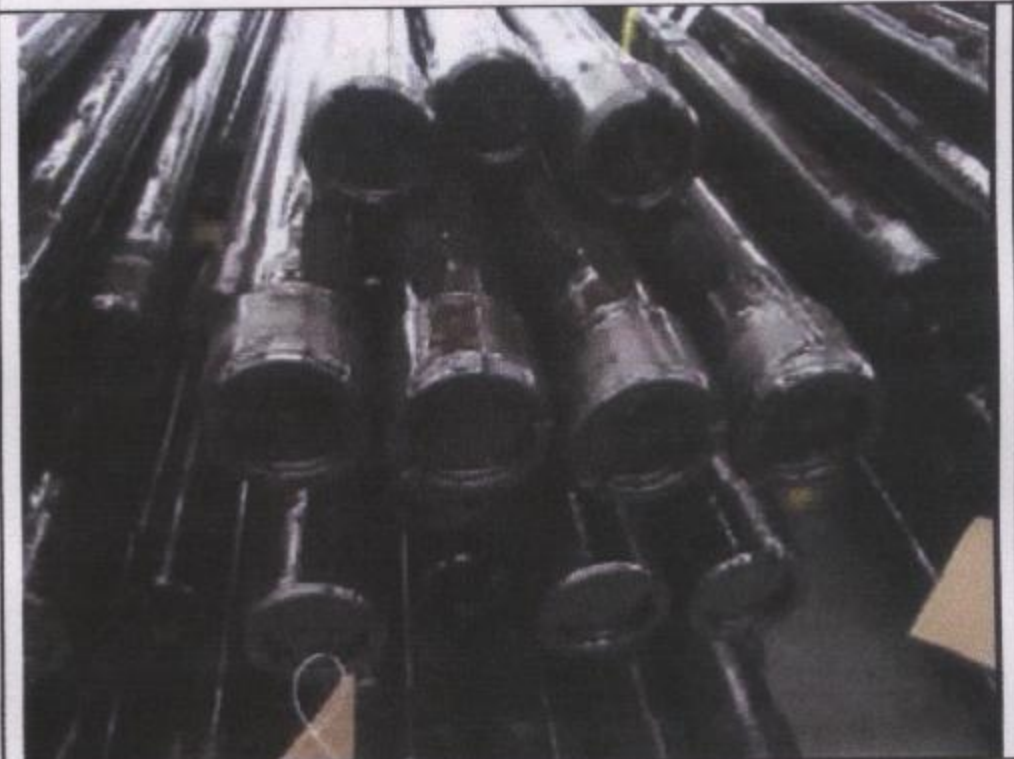
Male end had been put on protection caps.

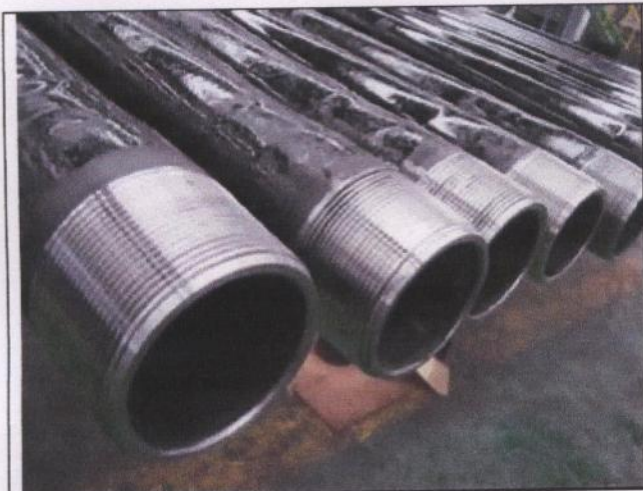
The pipe's end had been machined into screw, one end was male thread.

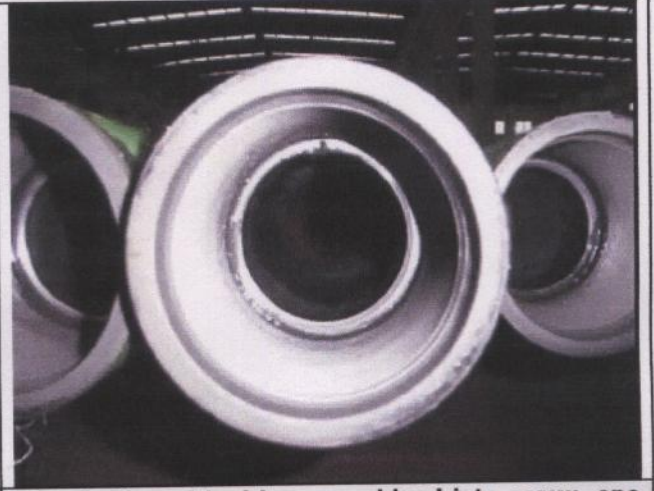
The pipe's end had been machined into screw, one end was female screw.

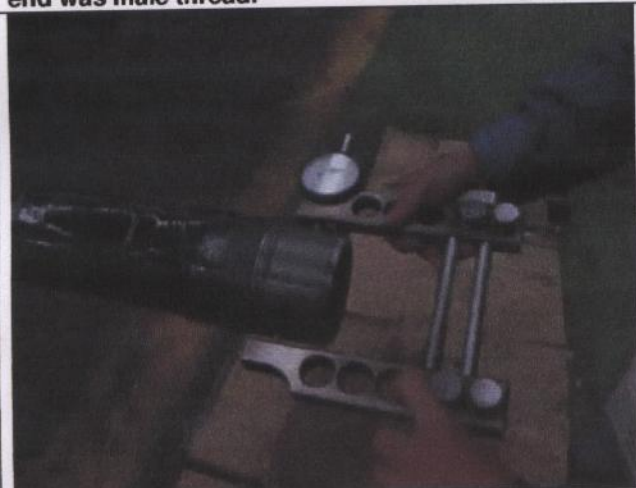
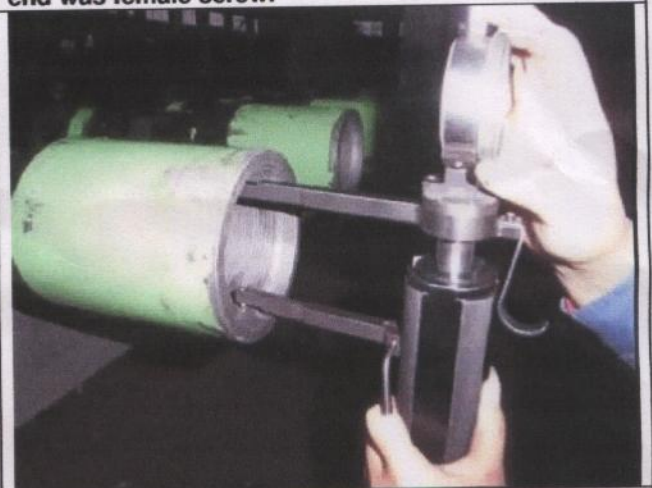
All checked data were acceptable.

Dimension check.

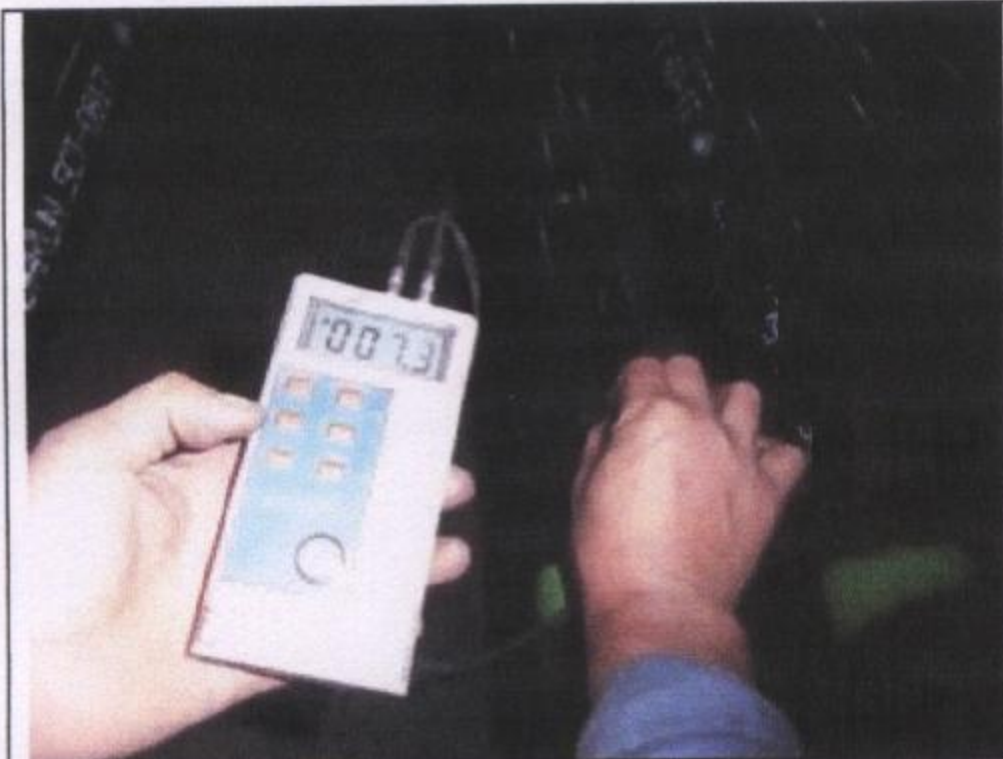
Wall thickness check.

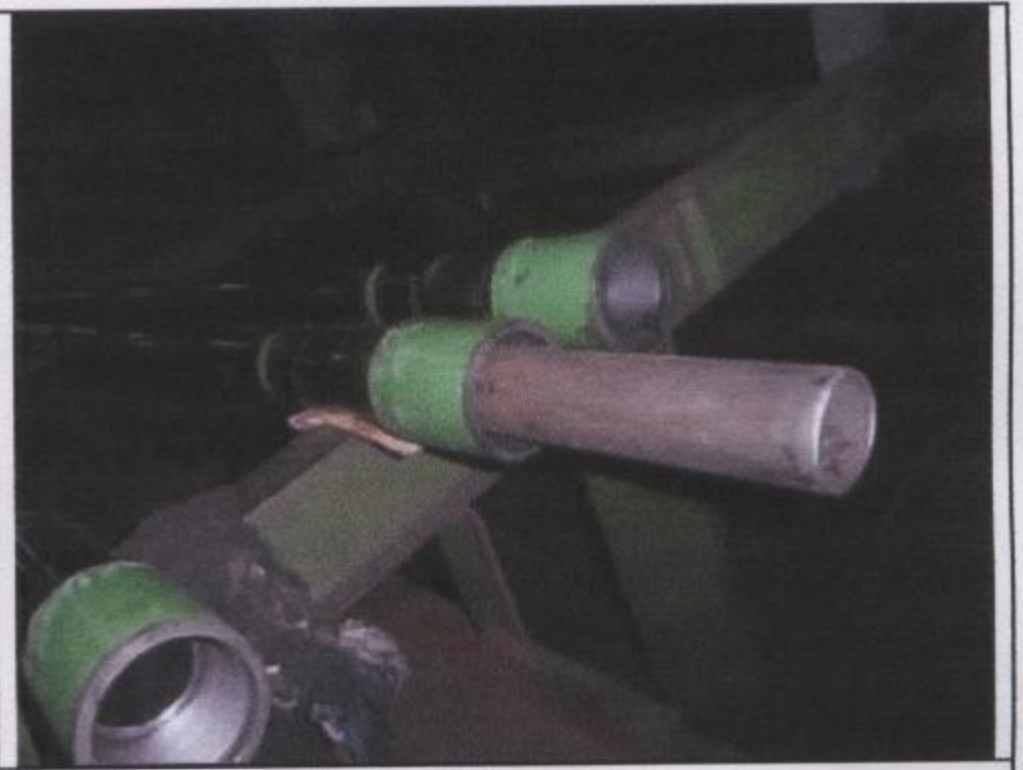
Test results: Passed.

Drift test.

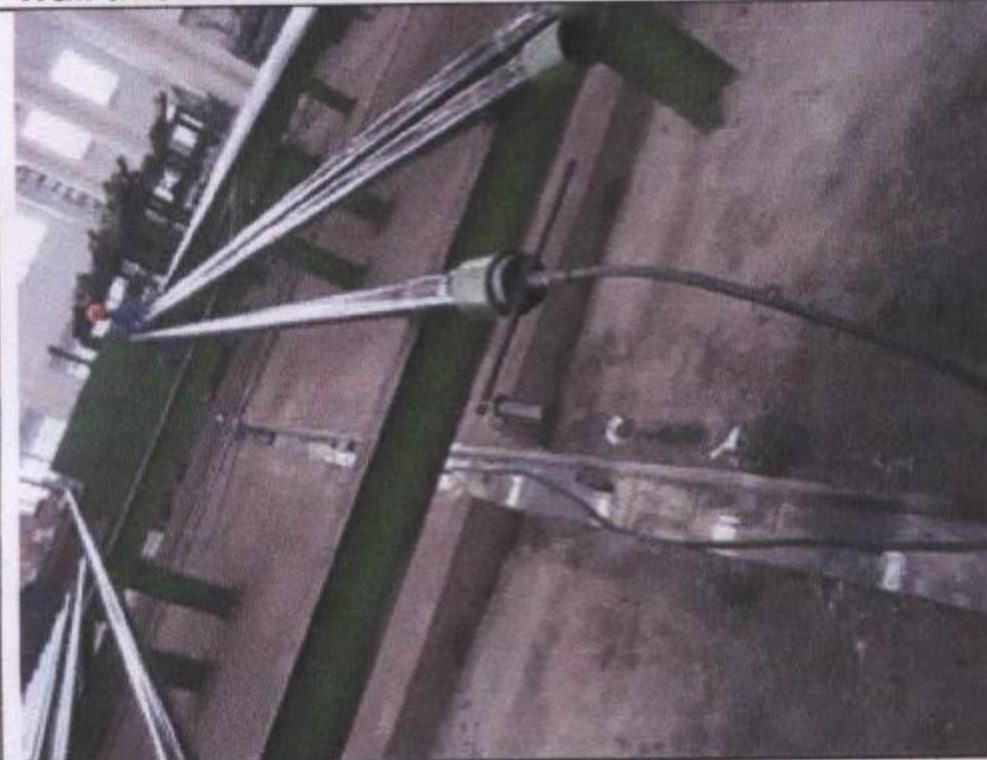
Test pressure: 44MPa

Duration: 10s

Results: No bulging or leakage was found.

The test results were acceptable.

Hydraulic test.

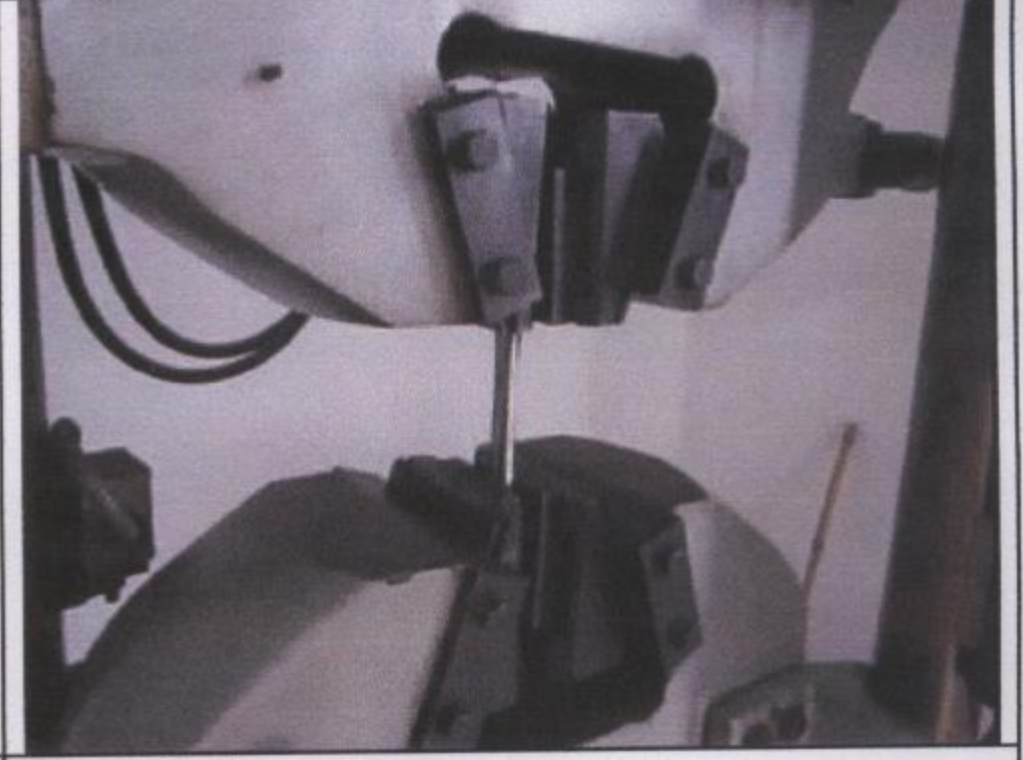
Tensile strength: 630 MPa

Yield strength: 455 MPa

Elongation: 29%

The test data were acceptable.

Tensile test.

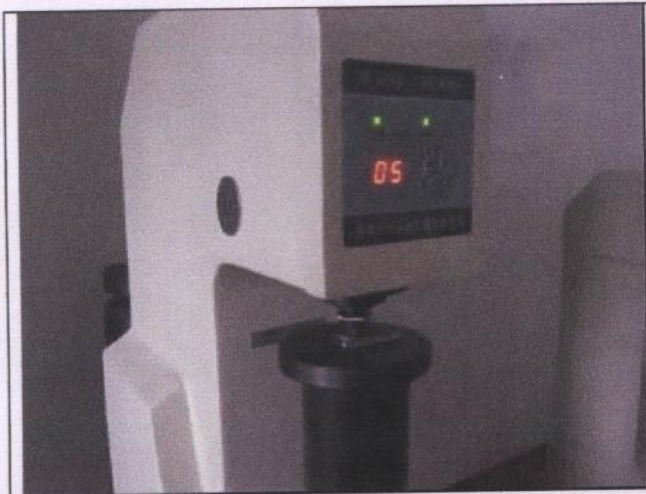
203 (HBW), 200(HBW), 197(HBW)

Average: 200(HBW)

The test data were acceptable.

Hardness test.

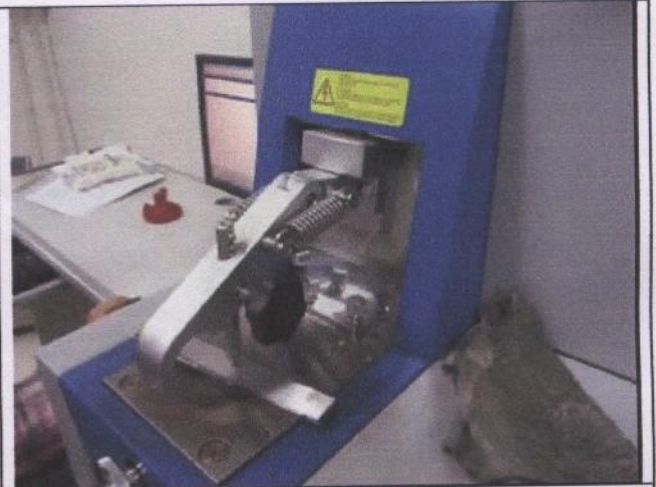
C: 0.26% Si: 0.21% Mn: 1.25% P: 0.014% S: 0.006% Cr: 0.02% Ni: 0.01% Cu: 0.02%

The test data were acceptable.

Chemical composition analysis.
