HEBEI ABTER STEEL PIPE CO., LTD

INSPECTION REPORT

Report No.: MIL 16/11/2010

Inspection Subject:	LSAW Pipes	Inspector:	Lin Gaojie	Stamp No:	
Specification:	API 5L B PSL2

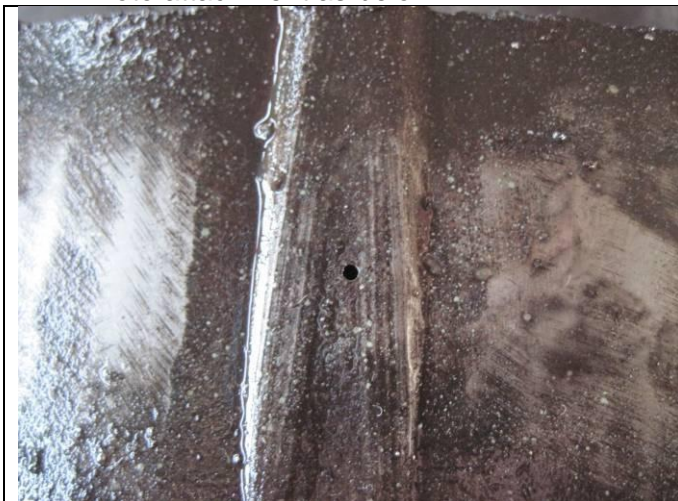
Hole size ϕ 1.6

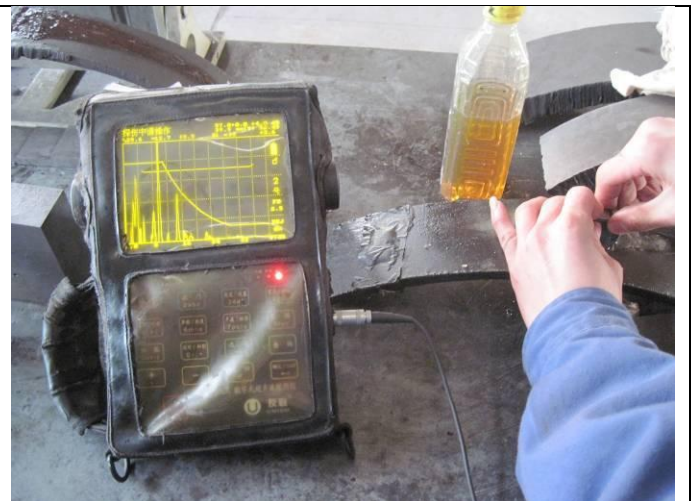
Ultrasonic fault detector calibration

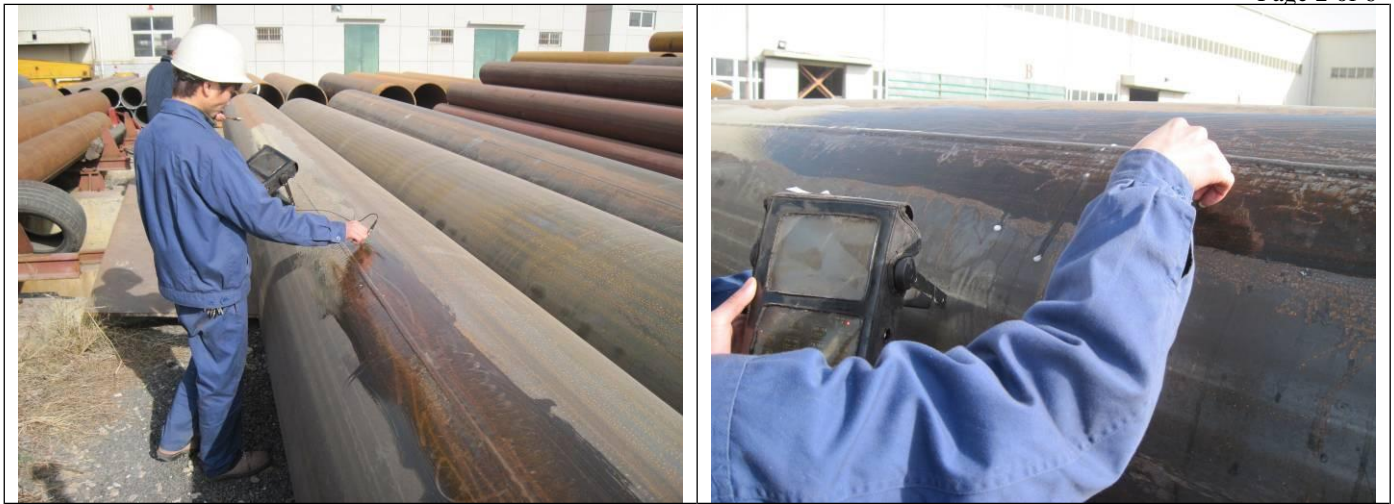
UT

We had verified the manual UT, and 6pcs of pipes (3pcs for 812.8*9.53mm*12m, 2pcs for 812.8*9.53mm*6m and 1pc for 914.4*9.53mm*12m) were all passed.

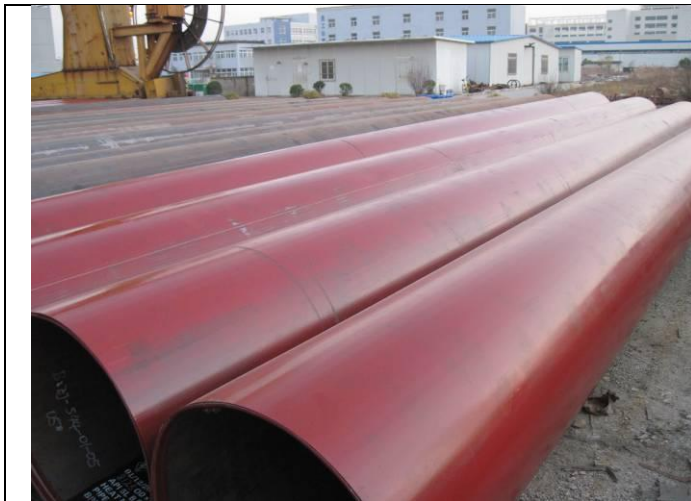
For checking

- 1) The pipes were painted with rust-proof paint by brush and **some uneven ones** had been painted again.

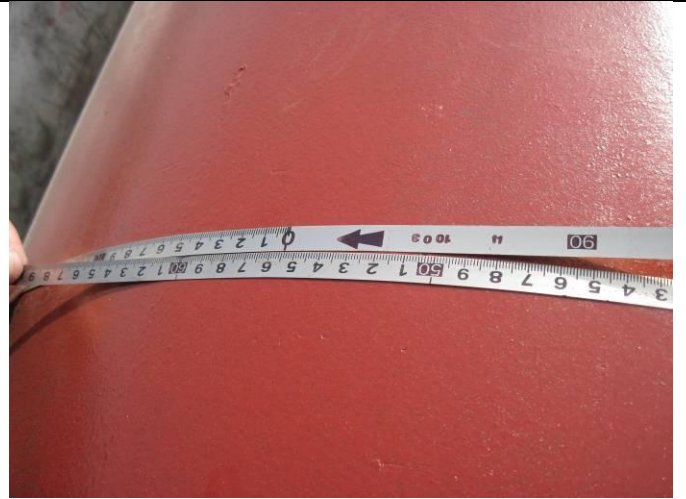
Measuring OD of pipe body

Spec (mm)	Inspection Amount (pc)	OD of pipe body (mm)	OD of pipe ends (mm)	Out-of-roundness (mm)	WT (mm)	Length (mm)	Straightness (mm)	Out-of-squareness (mm)
812.8*9.53* 12000	3	813.0~814.6	813.0~814.3	7~15	9.4~9.9	12012~12019	3~5	1
812.8*9.53* 6000	3	813.3~814.3	813.6~815.5	10	9.7~10	6005~6016	2	2.0~2.5
914.4*9.53* 12000	2	912.6~915.2	913.9~915.8	6~8	9.5~9.7	12005~12018	2~3	3

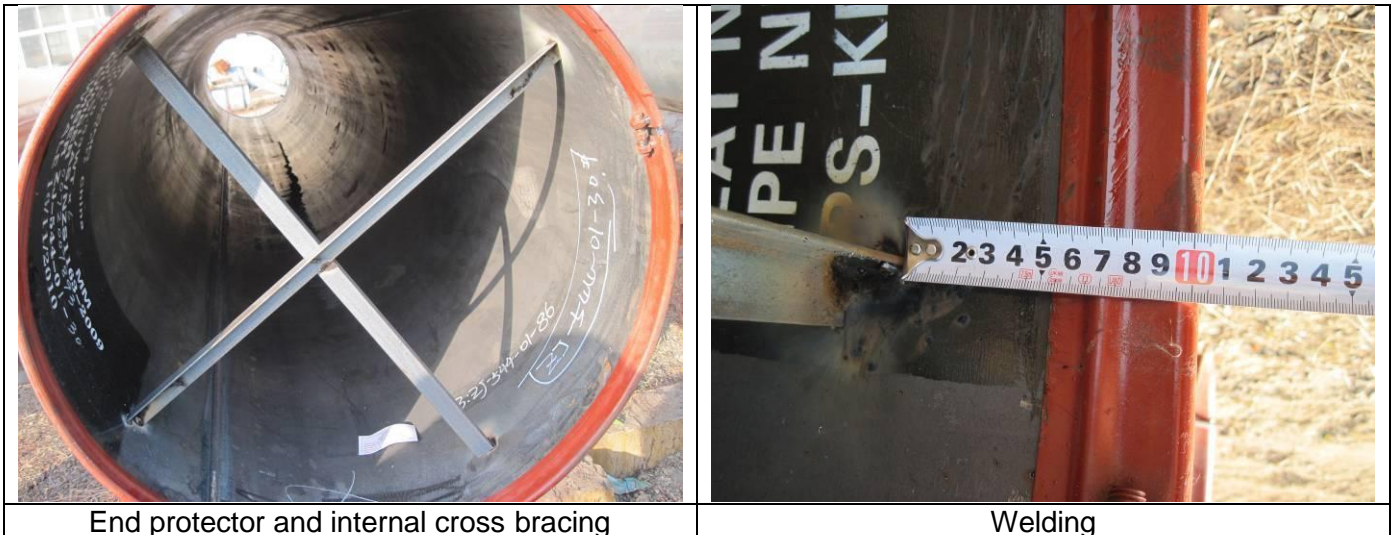
- 1) The mill had fixed end protectors on both of pipe ends;
- 2) The internal cross bracings were welded on the place about 200mm far away from end to avoid deformation.
- 3) The quantity was right;
- 4) The shipping mark was right;
- 5) The marking was right.
