<b>INSPECTION REPORT</b> <b>Report No.: MIL P09829-4</b> Issued on: Nov 25 <sup>th</sup> , 2014 Inspection Time: Nov 23 <sup>th</sup> -24 <sup>th</sup> , 2014	<b>P.O. No.</b> <b>PX-PSTS-</b> <b>0934557 PX-</b> <b>PSTS-0934528</b>
---	---

Inspection Subject:	Boiler Tubes				
Specification:	ASME SA213 T11/T22	Inspector:	Lin Gaojie

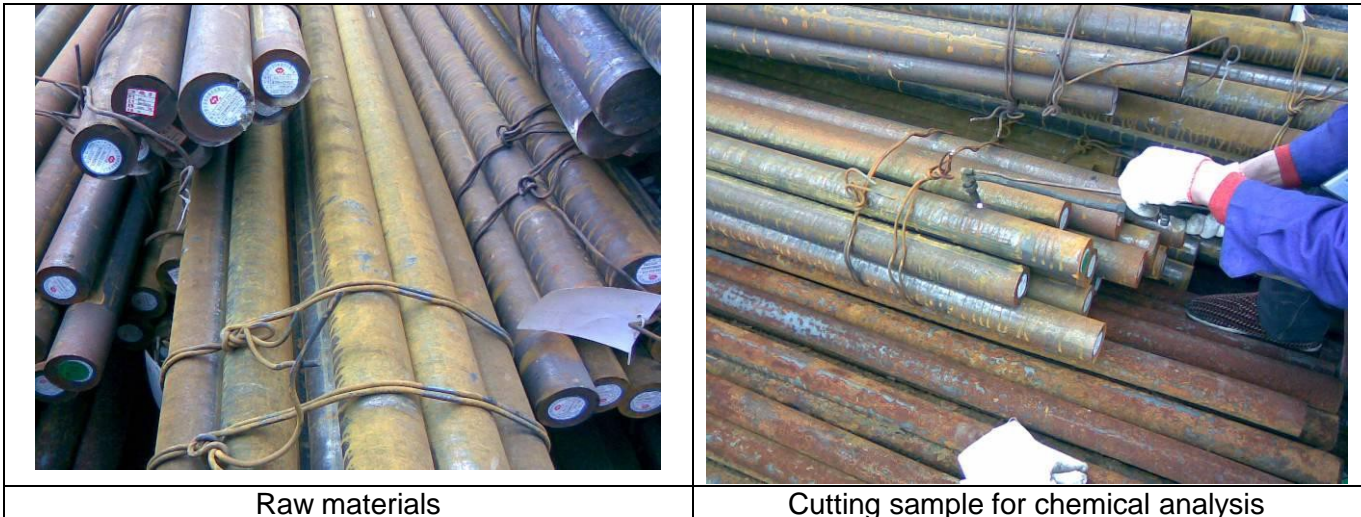
We had checked the visual quality and chemical analysis of the new raw materials, the Heat No. of which are H10906353 and H10906354.

They are all up to snuff.

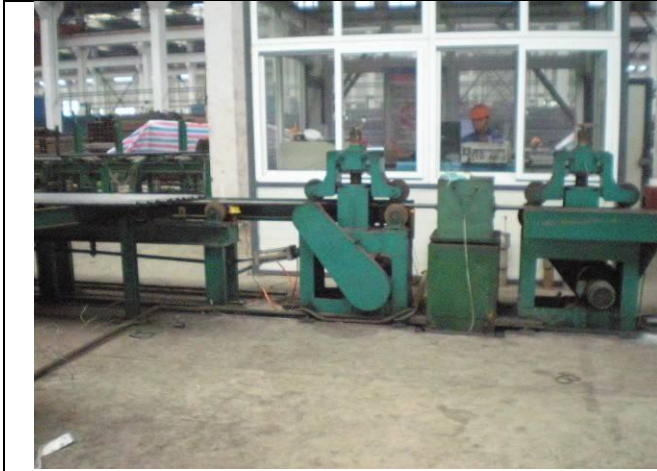
We had overseen the operation and checked the NDT Report. The notches for Ultrasonic Test and Eddy Current are qualified according to the norm.

Eddy Current Testing

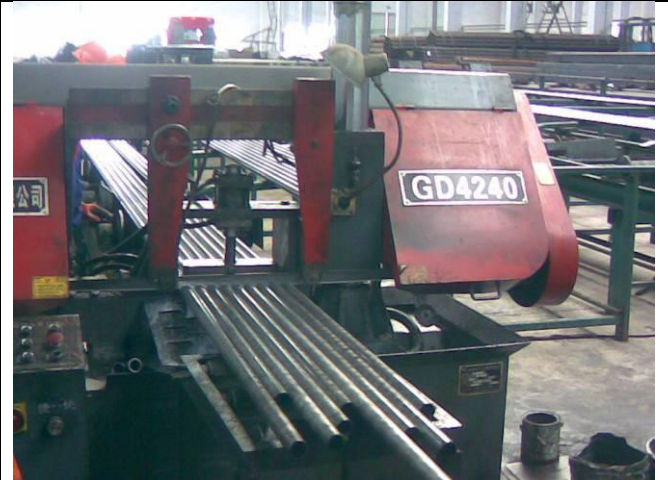
Being cut off

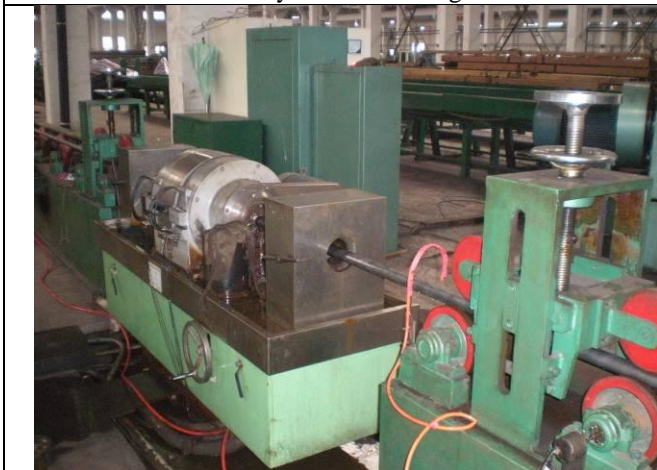
Ultrasonic Test

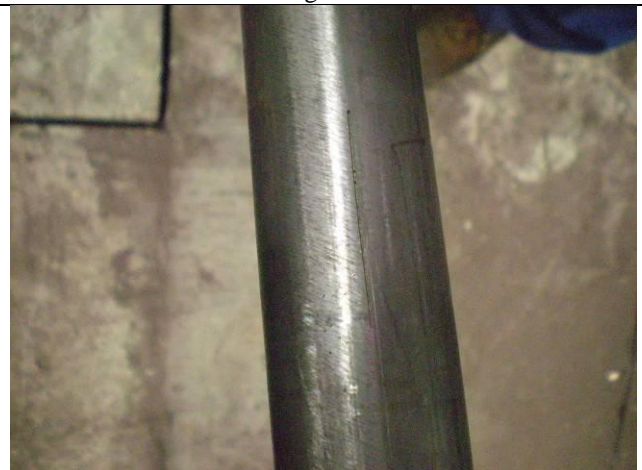
Notch for Ultrasonic Test

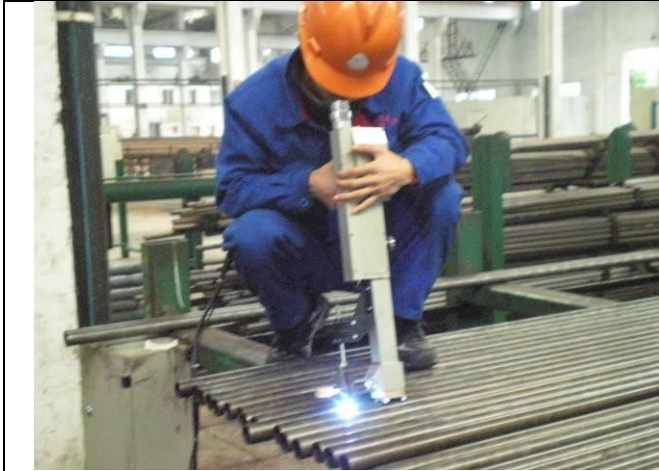
PMI

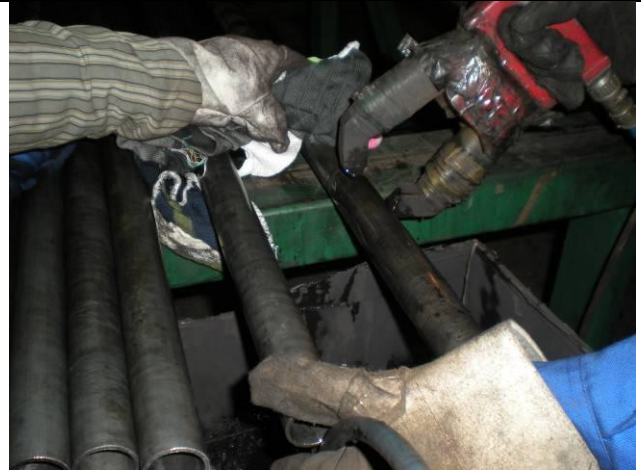
Magnetic Particle Examination

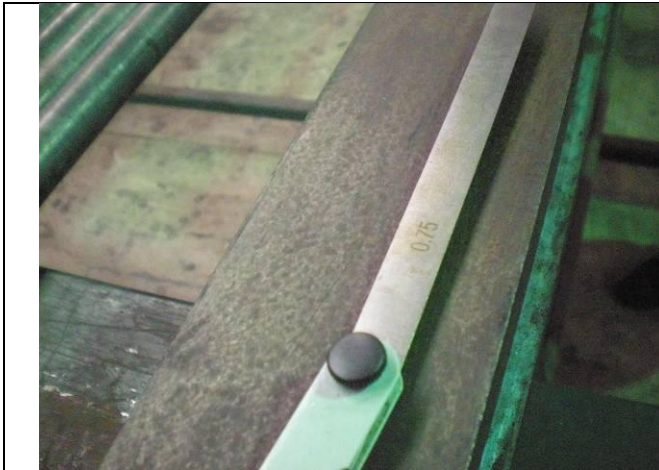
The spec of feeler leaf that we used is 0.75mm, while the maximum curvature is 0.89mm/m.

Feeler gauge

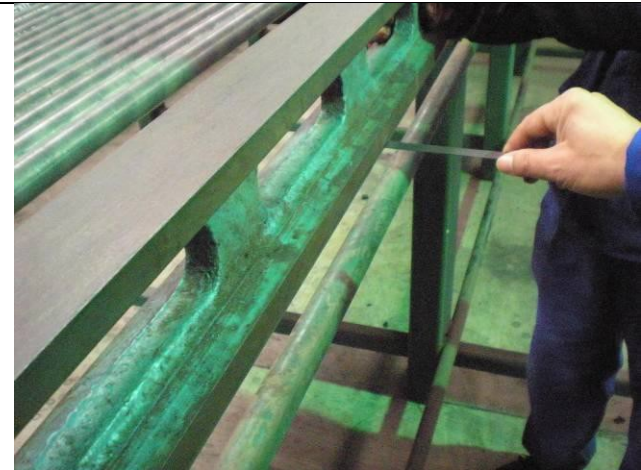
Measuring the straightness

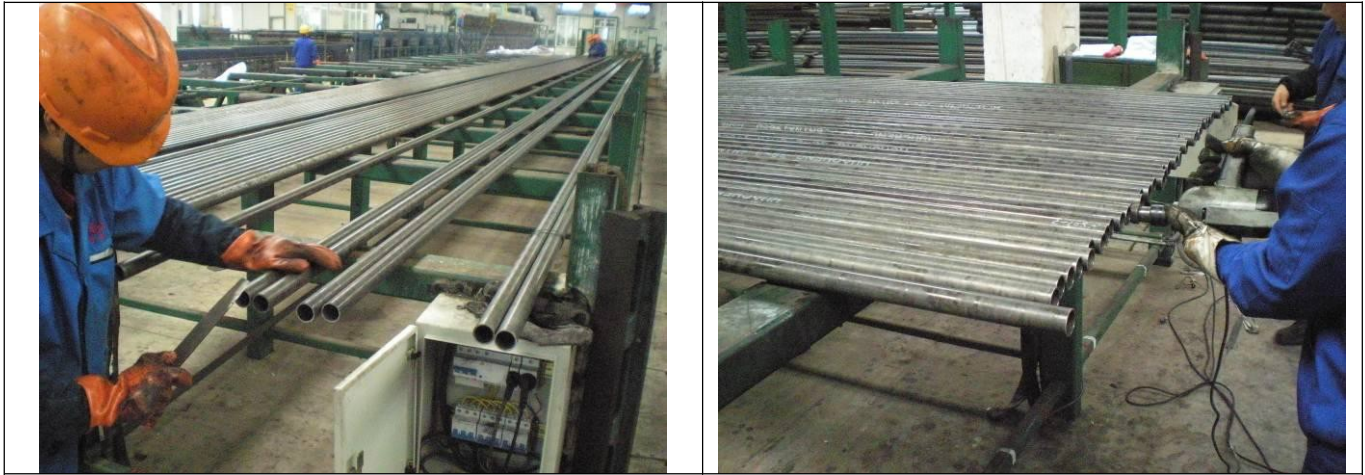
Tube ends have squared cut and are free from excessive burrs.

Wiping off the excessive burrs

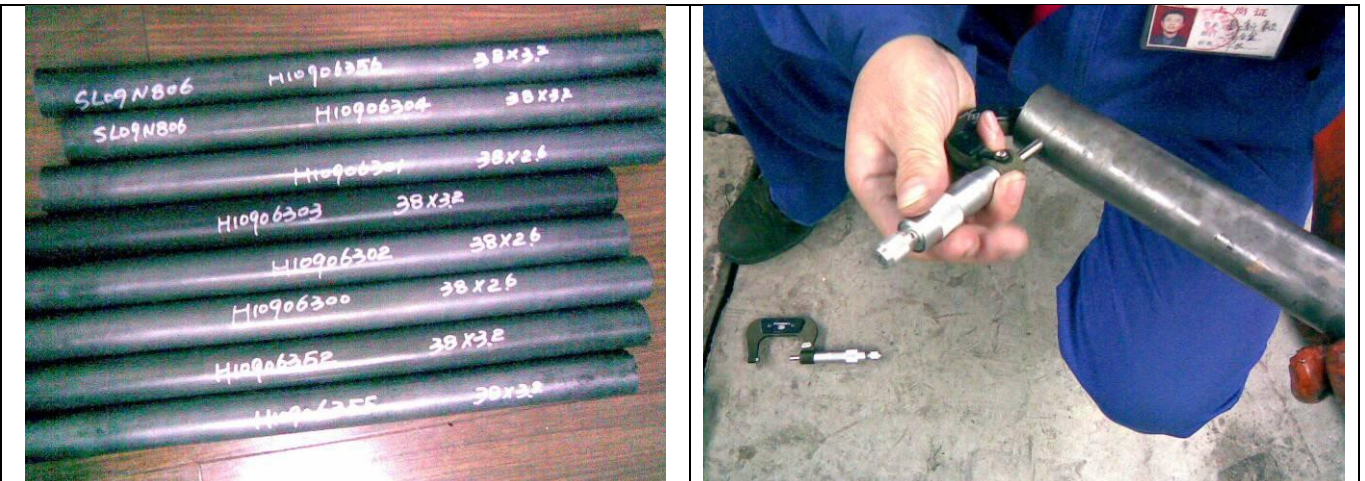
There are about 10 samples having been taken, and we had verified them. The rest samples will be cut off on the witness of Moody Inspector according to the decision of our meeting on Nov. 20<sup>th</sup>, 2014.

Samples

Measuring the dimension

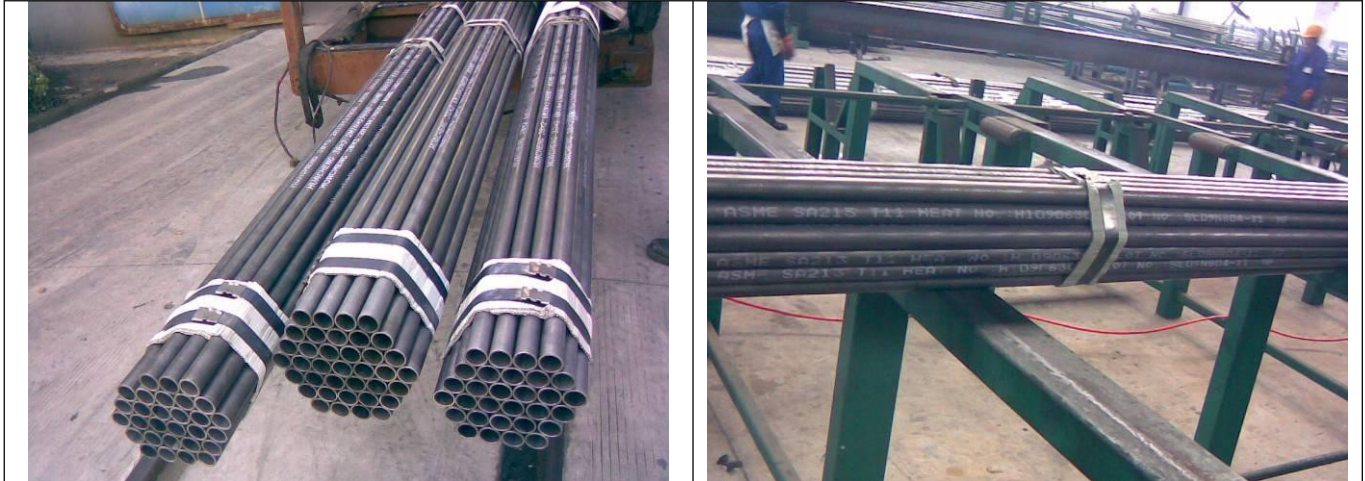
Moody Inspector chose three bundles of tubes randomly for inspecting. The mill provided Moody the report of production and inspection.

For inspecting

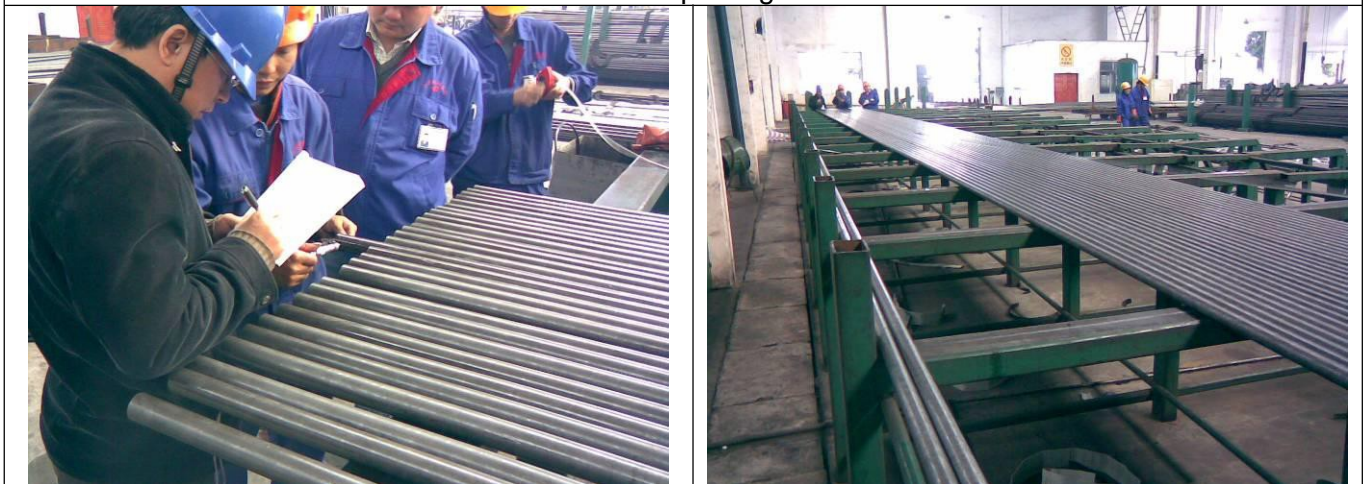
Inspecting

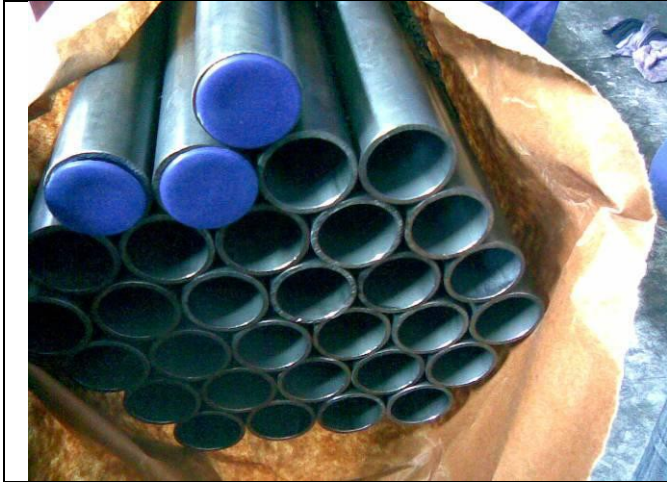
Plugs on tube ends

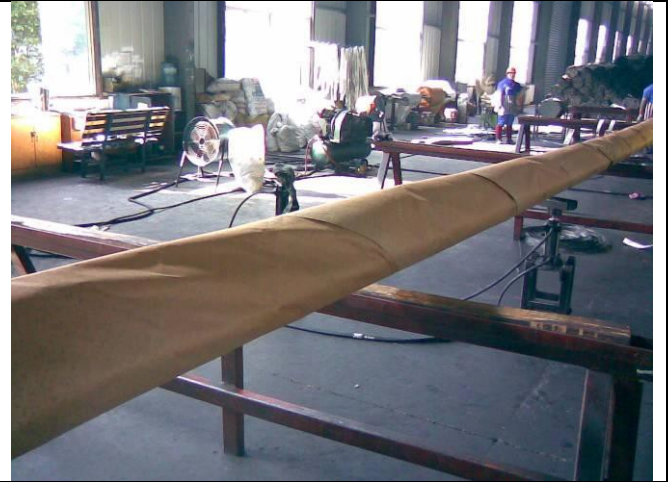
The first wrapping: Moistureproof paper

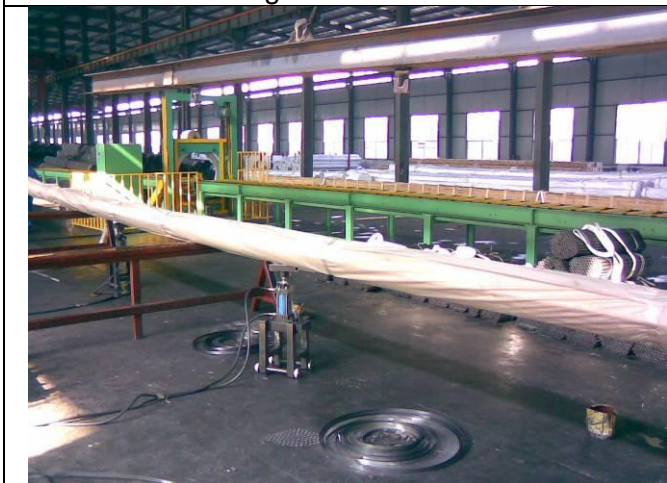
The second wrapping: Ploy bag

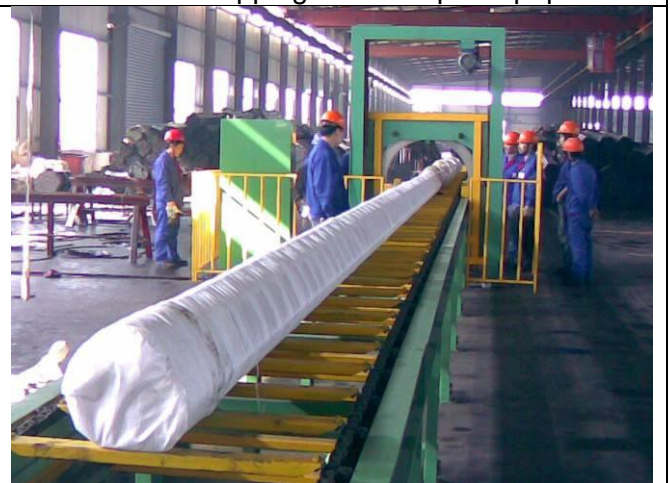
The third wrapping: Polypropylene knitted bag

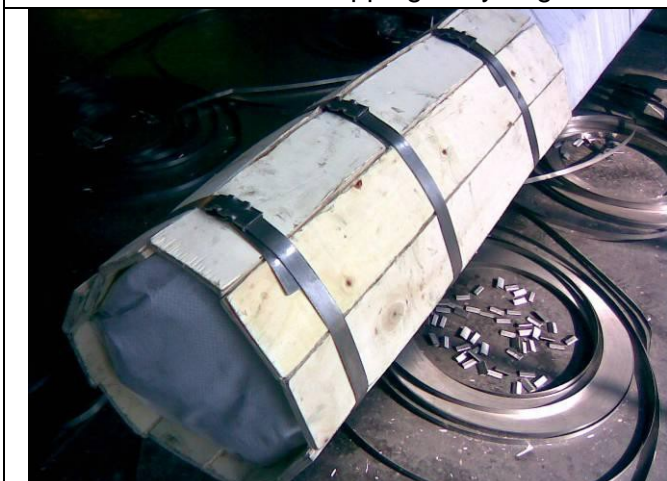
The last wrapping: Batten and metal band

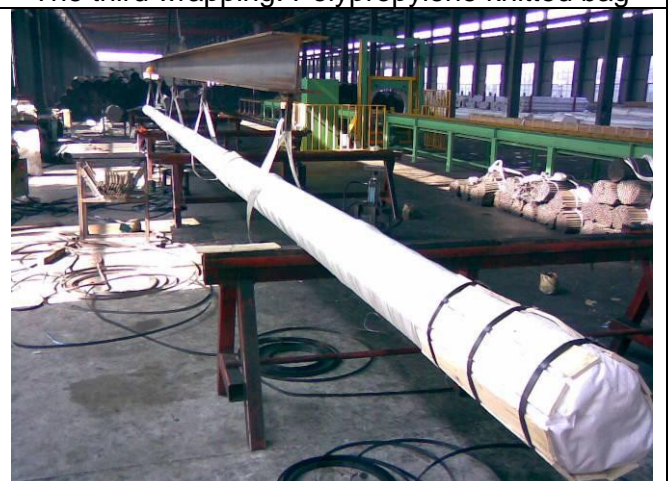
The final packaging of tubes is including plugs on tube ends and four different wrappings in order to avoid damp, damaged and bend in transit.

The final packaging

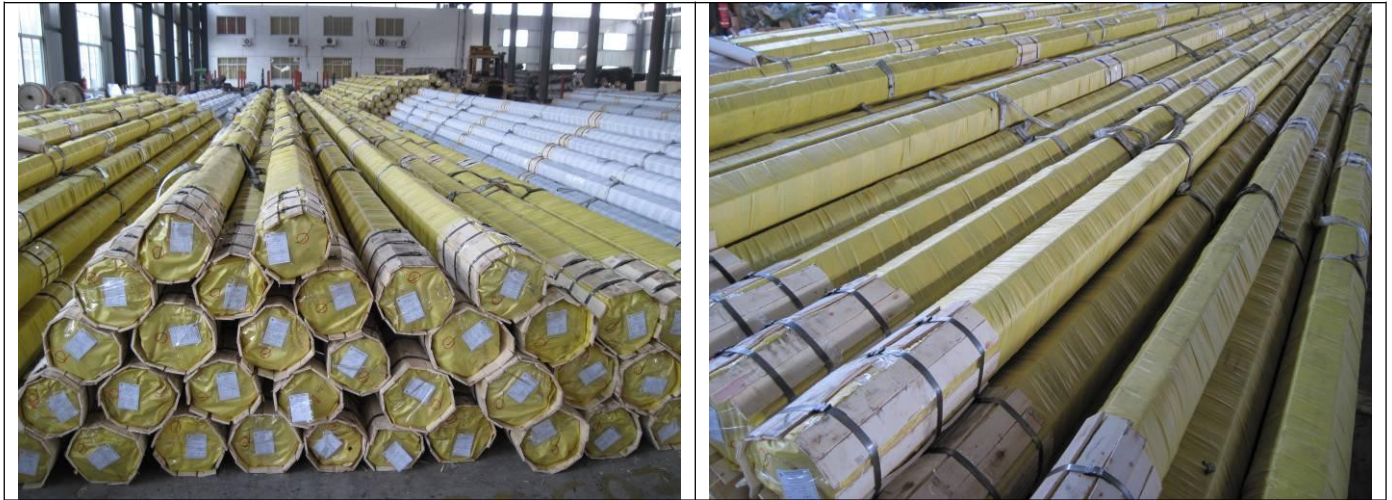
The first batch of cargo had been carried by truck to the storage where the tubes will be baled into big bundle. We had overseen the operation and the tubes are good after being loaded into the truck. There are two trucks to carry the tubes, the Modul of which is HP EVAP-MODUL 3. The light broken package had been repaired.

The tubes

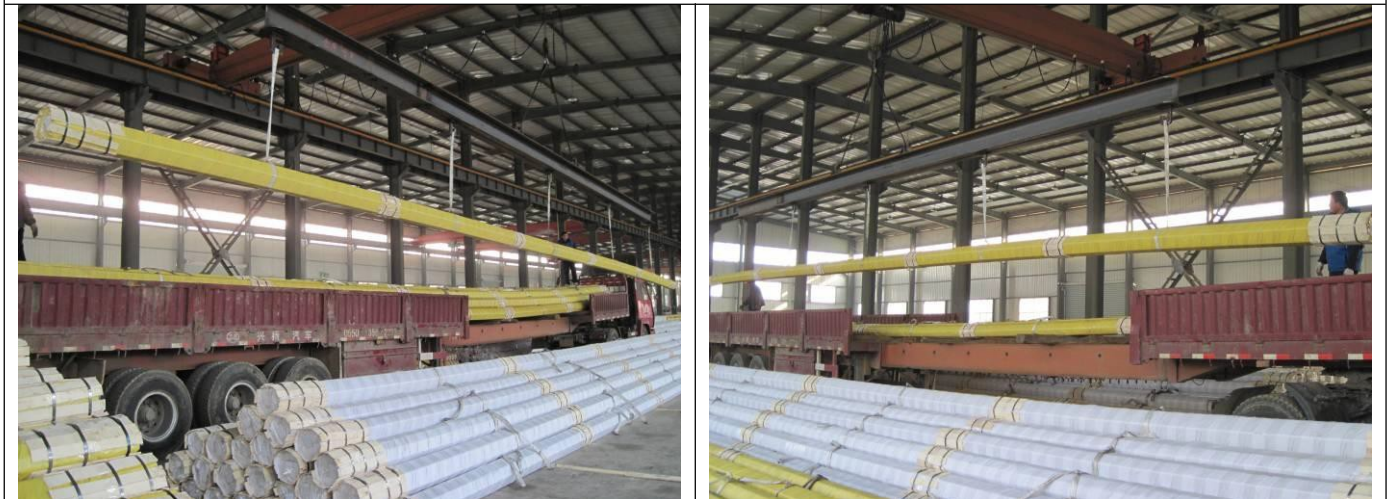
Being loaded into the truck

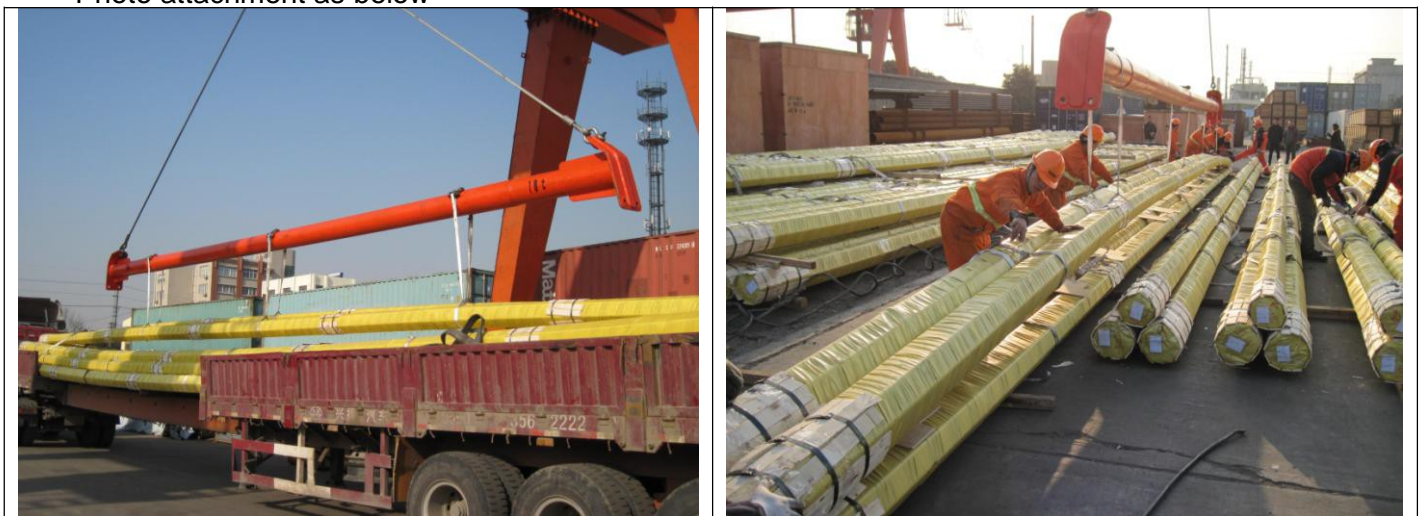
The first batch of cargo had been discharged and baled into big bundle. We had overseen the operation.

Discharging

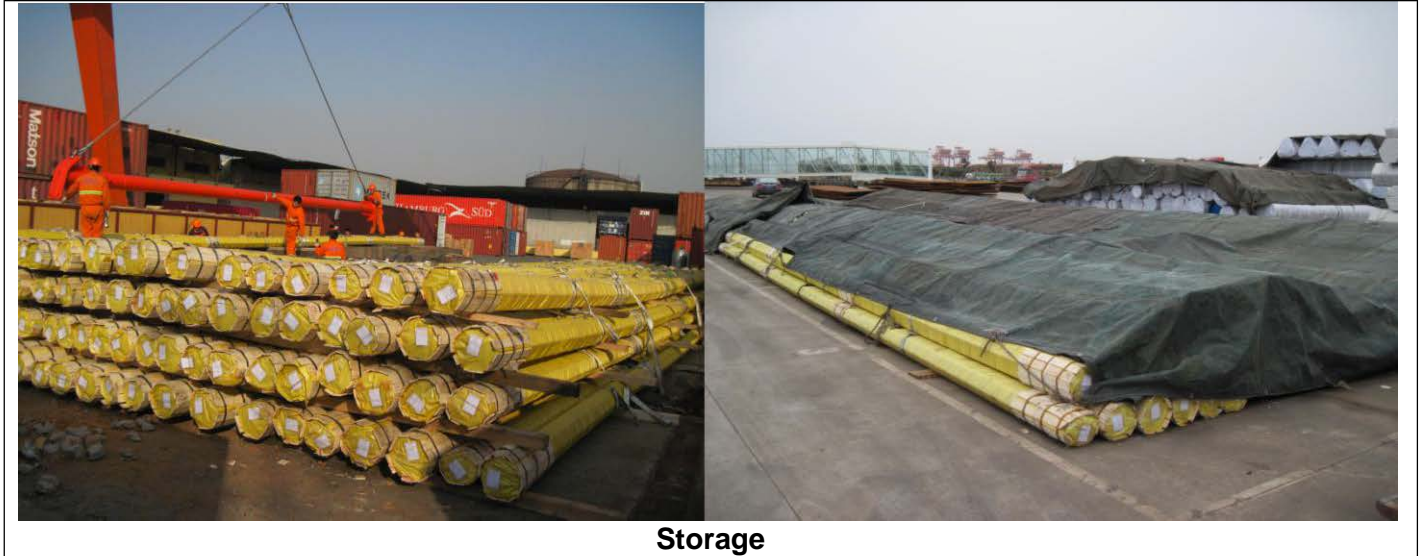
The tubes had been covered by tarp before shipping.

Storage
